**Presented to the:**  
**New Jersey Board of Public Utilities**

## **Final Report**

**Focused Audit of the Planning,  
Operations and Maintenance Practices,  
Policies and Procedures of  
Jersey Central Power & Light Company  
Docket No. EX02120950**

**June 22, 2004**

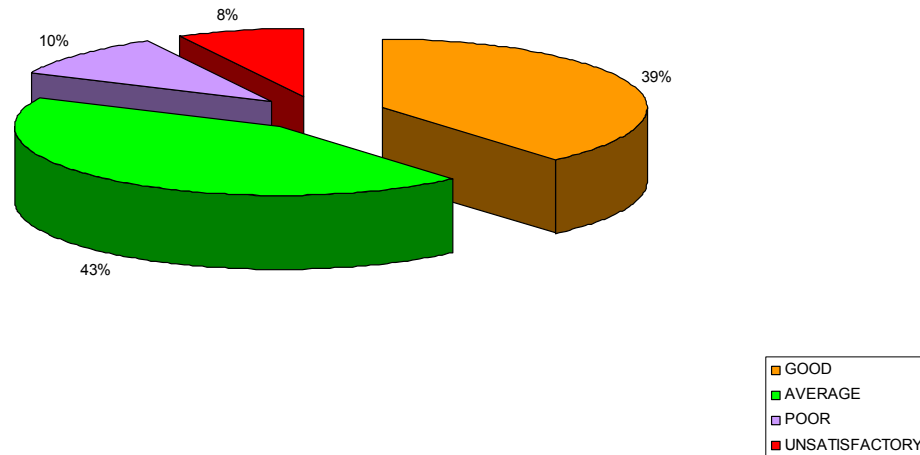
*Figure 1*

Eight percent (8%) of the sampled facilities were observed to be unsatisfactory and in need of immediate attention. Ten percent (10%) of the facilities were observed to be poor, requiring maintenance and/or replacement in the near future. Appendix B contains our Engineers' written evaluation of the 34.5 kV subtransmission circuit inspections conducted during our condition assessment. Also included are photographs and summary discussions for all locations rated as unsatisfactory or poor. The final section in Appendix B is a cost estimate projecting the total material and labor costs required to repair or replace facilities observed to be in unsatisfactory or poor condition.

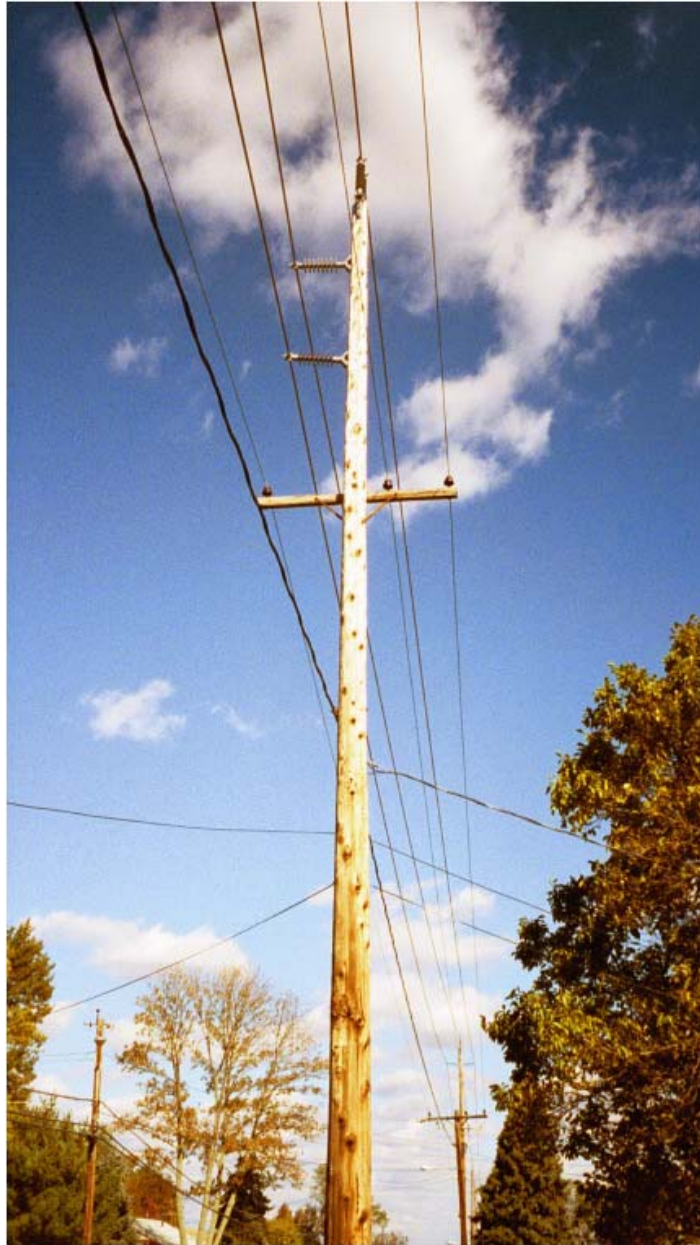
*Photo 1*

Of the 518, 34.5 kV subtransmission poles inspected, we identified 40 that needed to be replaced due to age, deterioration or rot. That reflects about 8% of the poles inspected. We did not have an exact number of subtransmission 34.5 kV poles from JCP&L. Assuming 1,494 miles of 34.5 kV subtransmission lines inspected and 290 feet for an average span length, we estimated 26,890 poles were associated with 34.5 kV. On a pro-rata basis, 1,882 would need to be replaced in the near term. Again, this number is not exact but it does provide a magnitude of the percentage of poles that need replacing. Trying to identify one cost associated with the replacement of a 34.5 kV sub-transmission pole was impractical if not impossible. The factors involved with replacing these poles vary a great deal. In an effort to estimate a reasonable replacement cost, the poles were grouped in three types: Type 1, Type 2 and Type 3. Each type was priced based on the average

complexity and difficulty to replace the poles. On a pro-rata basis, 1,187 poles were grouped as a Type 1 replacement (Photo 1):

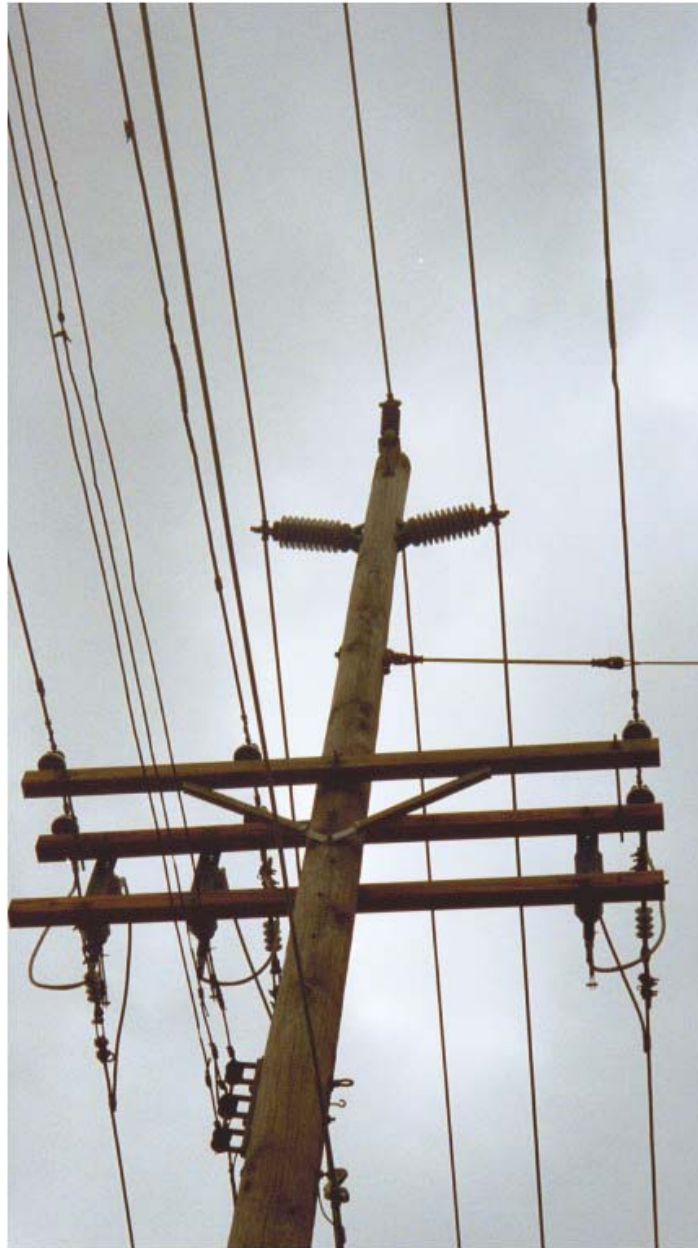
*Photo 2*

568 poles as a Type 2 replacement (Photo 2):

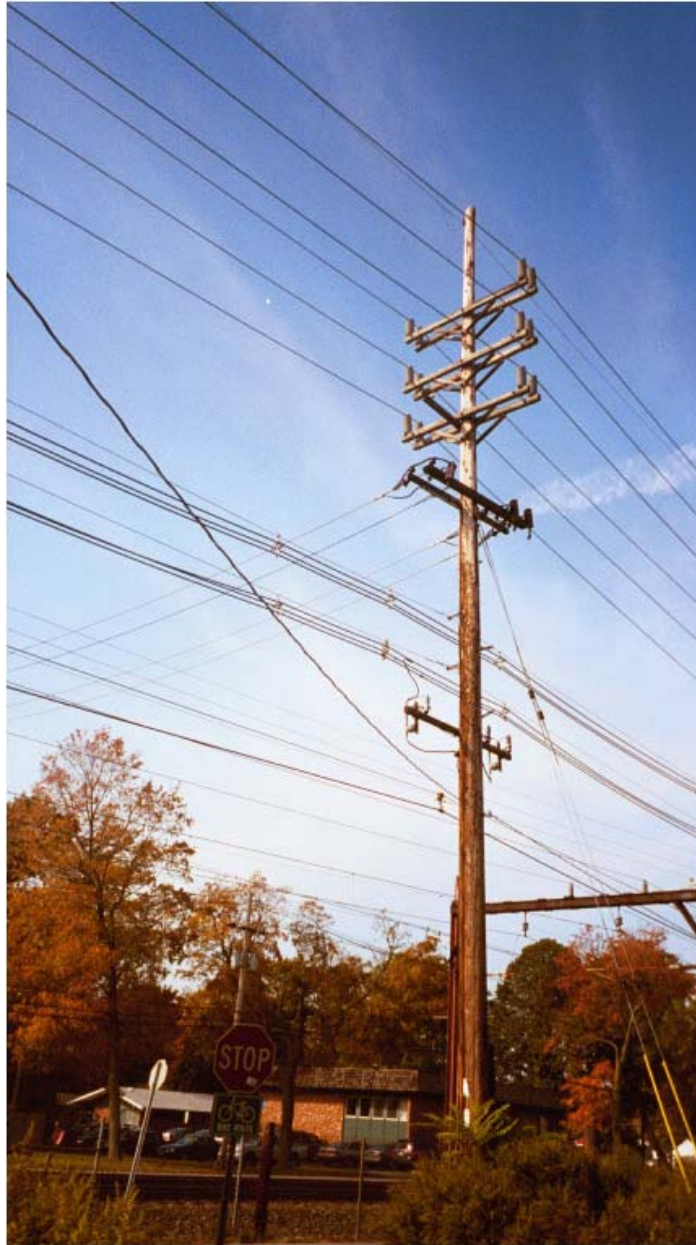
*Photo 3*

and 155 poles as Type 3 replacement (Photo 3).

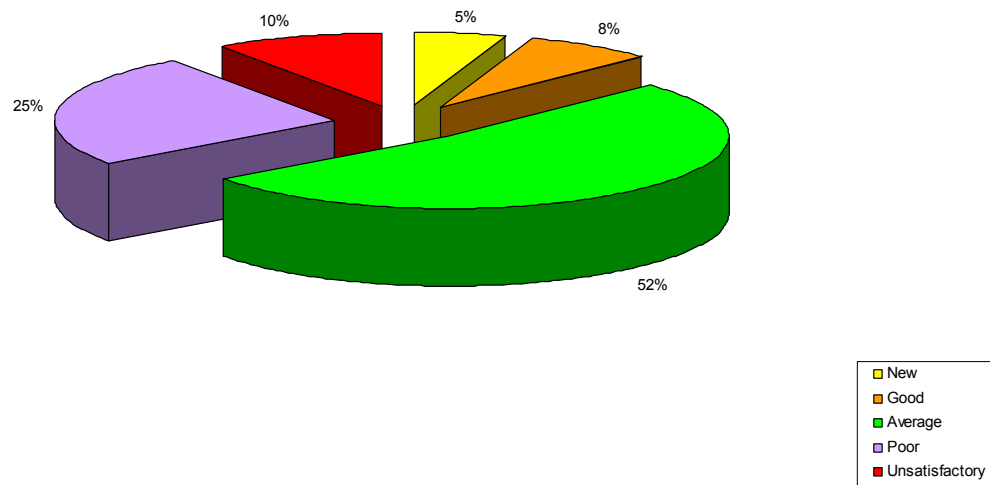
**Figure 6**

With respect to distribution facilities (poles, conductors, cross-arms, and pole-top transformers), approximately ten percent (10%) of the facilities inspected by our Team Members were observed to be unsatisfactory and in need of immediate attention. Twenty-five percent (25%) of the facilities inspected were observed to be poor, requiring maintenance and/or replacement in the near future. A list of all sampled facilities rated as unsatisfactory or poor, as well as photographs (where available), is shown in Appendix D.

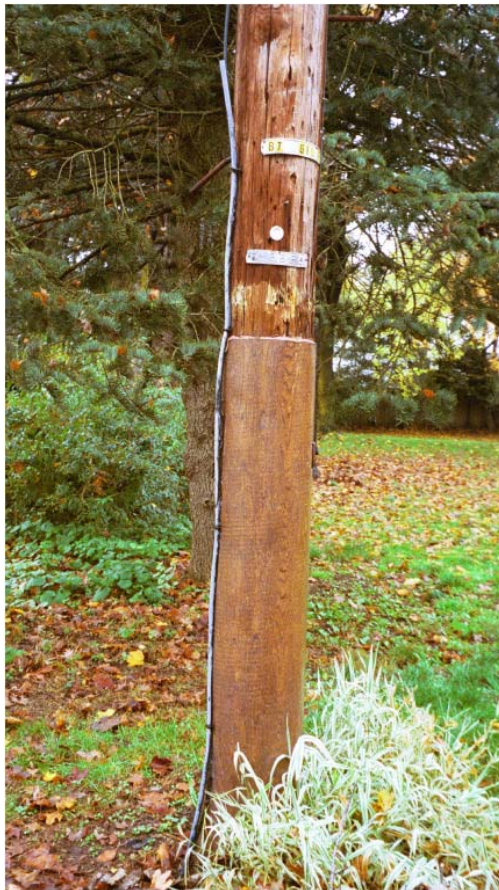
*Photo 4:*

The pole in Photo 4 has a considerable amount of surface damage. The pole has been reinforced with a fiberglass splint at the base. This should only be a temporary fix to allow time to replace the pole. The pole in Photo 5 shows another method commonly used by JCP&L to repair a split pole rather than replacing it.

Rotten poles were patched or otherwise temporarily secured instead of completing a permanent replacement. This is certainly not good utility practice and should only be used for emergency situations or for short-term repair.

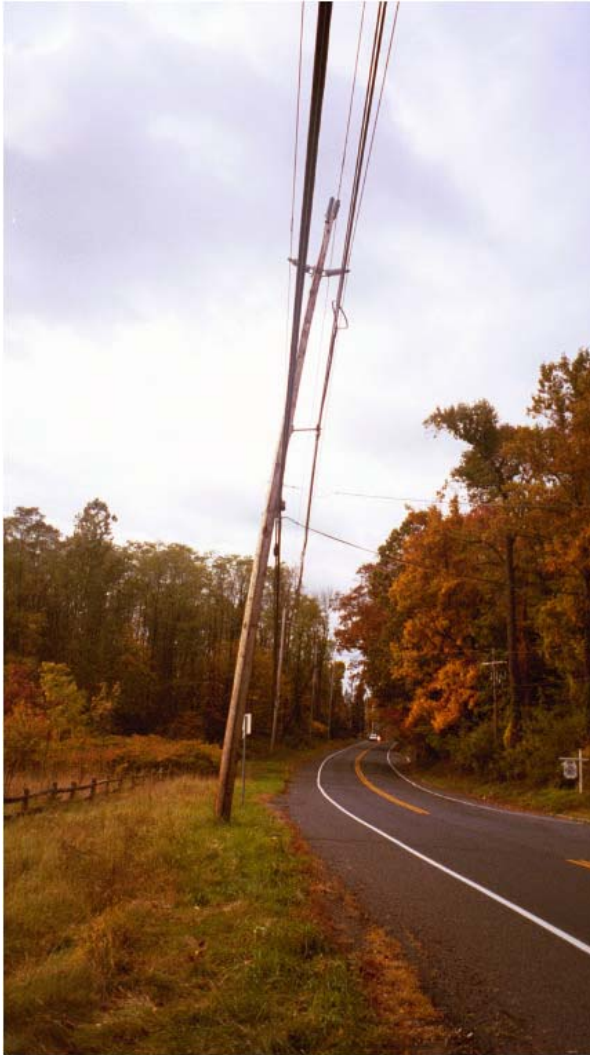
*Photo 8*

Our interviews determined that the staff and construction personnel involved in work order preparation and construction had no knowledge of guying strength requirements, standards, or transverse loading calculations. Poles requiring guys and anchors were also observed without any guy and anchor (see photo 8).

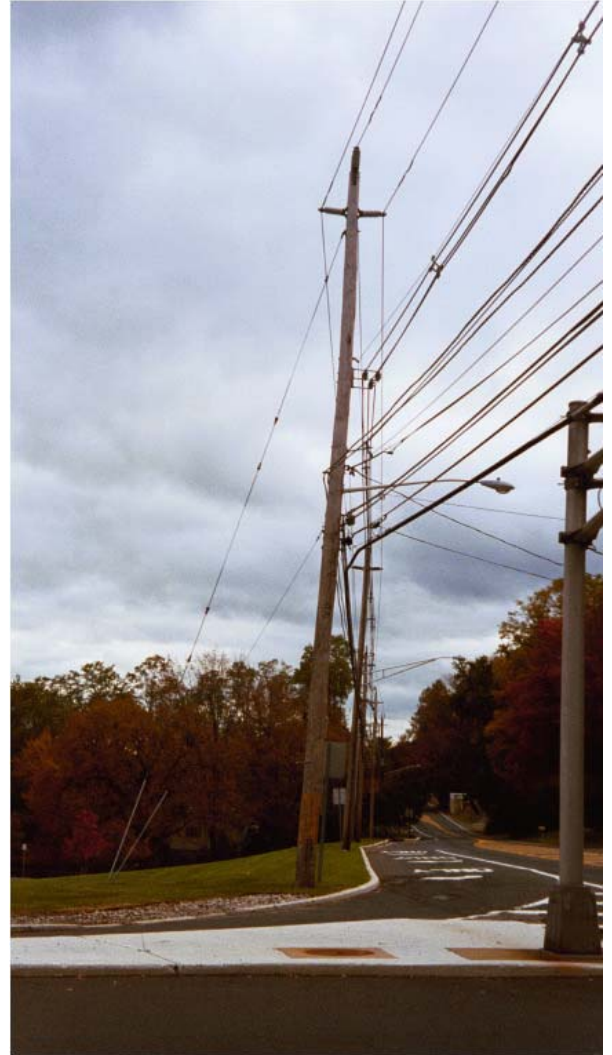
*Photo 9*

Furthermore, the majority of the system sample that we observed contained improperly applied guys and anchors (see photo 9).

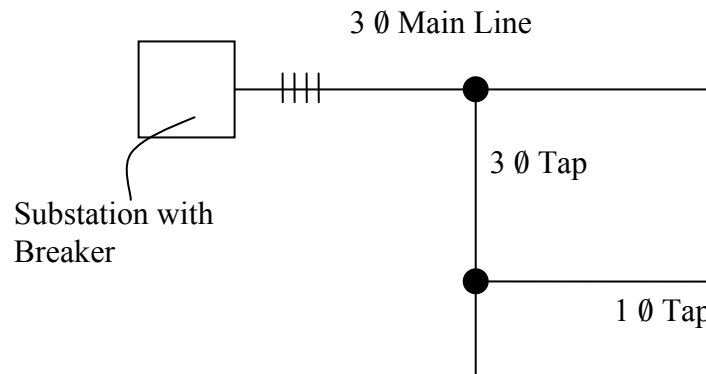
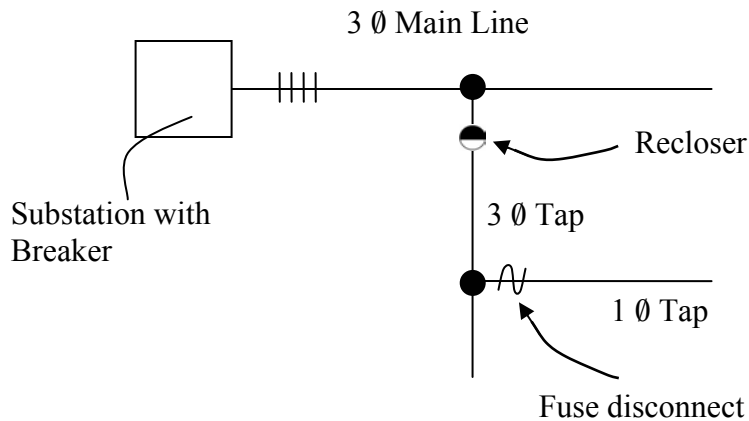
The following one-line sketch is an example of what was observed versus what should be established by JCP&L through its Accelerated Reliability Initiative. Increased sectionalizing will reduce the number of customers outaged and the duration of the outage. The present JCP&L plan is simply a start at a system-wide protective coordination program.

Paragraph 4 of the MOU and, to the extent that JCP&L agrees to fully comply with its Asset Management Strategy (AMS) document including the CRI program, which agreement is reflected in the Stipulation of Settlement (which includes the published AMS to which JCP&L has agreed to abide) entered into on June 8, 2004 by JCP&L and Board Staff (and which was reviewed and adopted by the Board), resolves the remainder of this concern.

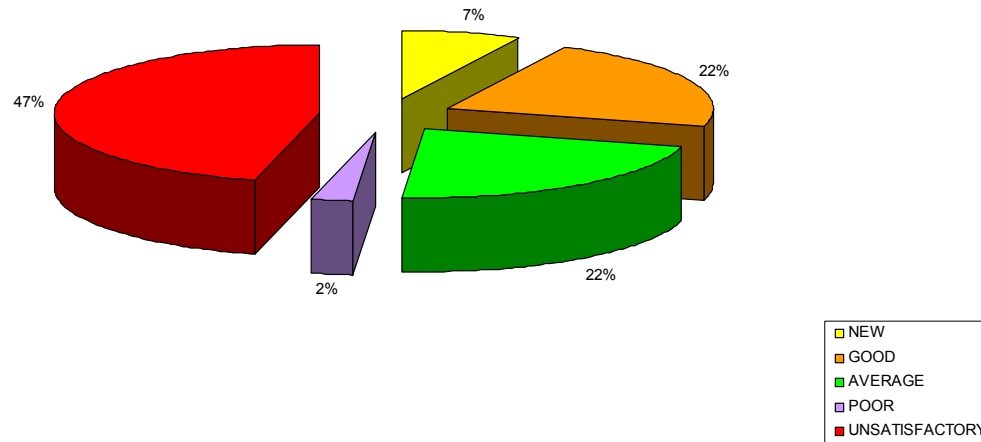
JCP&L - PAD-MOUNTED TRANSFORMERS  
CONDITION OF SAMPLED TRANSFORMERS AFTER QC

Forty-seven percent (47%) of the sampled pad-mounts were observed to be unsatisfactory. Two percent (2%) of the pad-mounts were rated as poor.

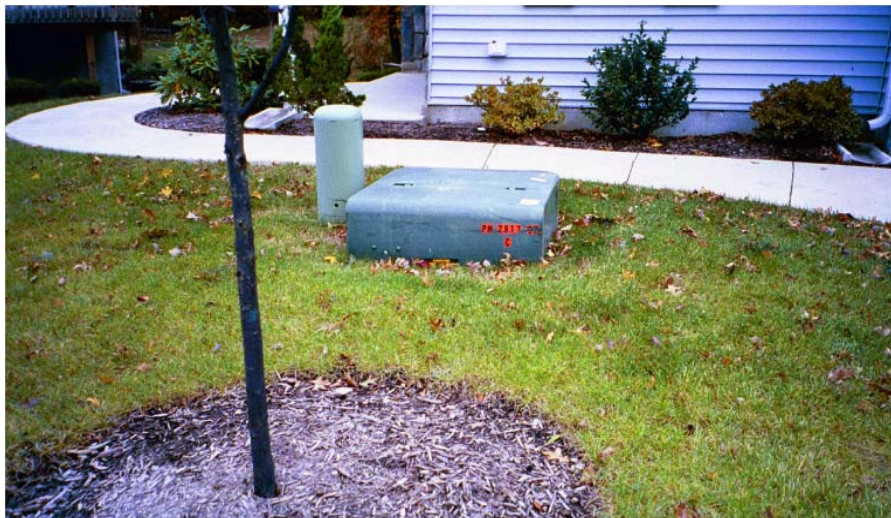
**Photo 13**

(4) *Termination.* A few transformers had elbows that appeared to show signs of early electrical breakdown. Our recommendation was to replace and re-terminate the elbow only.
